# Manhole Inspection Summary

Manhole # S53M\_\_012MH

Insp Date: **4/7/08 10:23 AM**

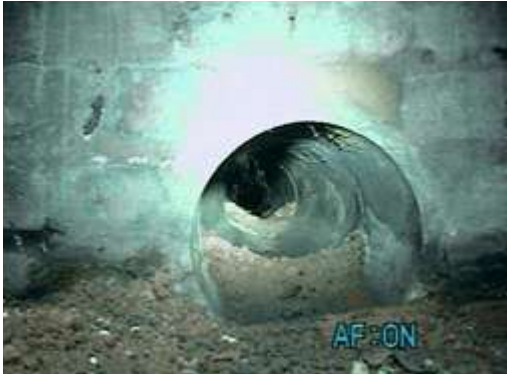
Defect 2

Condition: ☐ Sound ☐ Cracked ☐ Root Intrusion ☐ Deteriorated ☐ Leaks ☒ **Debris**

channel cond debris

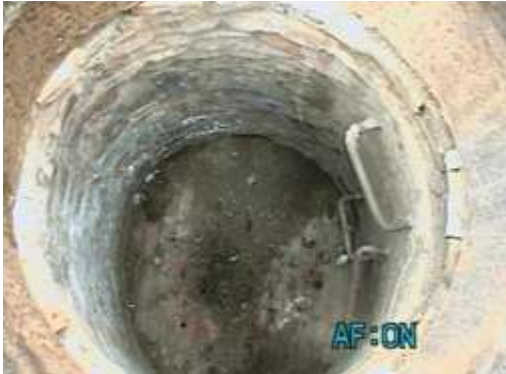
Defect 1

Count: **3** Missing: **0** ☒ **Corroded**

steps

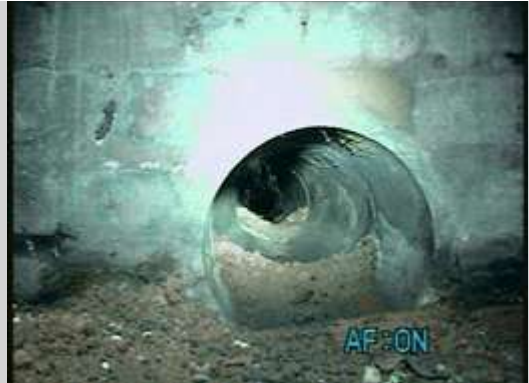
12 O'Clock Outflow

8 in. Circular Gravity Sewer  
Pipe Out @ 12 O'Clock

Deposits: ☒ None ☐ Mud ☐ Sludge ☐ Debris ☐ Grease

Infiltration: **None** Pipe Seal Cond: **Unknown**
